pink home inspection INC

Property Inspection Report

Inspection date: **Thursday, May 08, 2014**

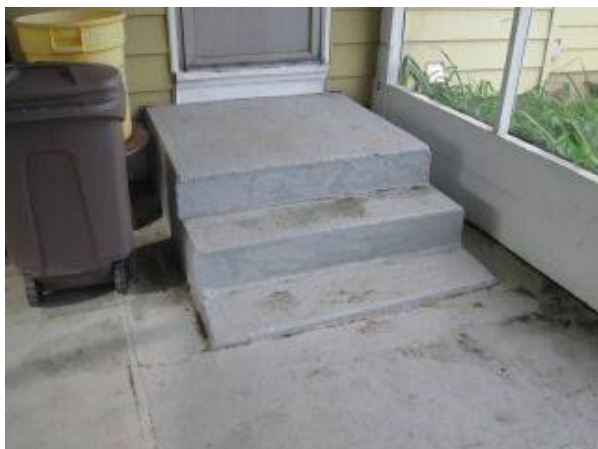
Photo 4-1

The risers for stairs at one or more locations varied in height and pose a fall or trip hazard. Risers within the same flight of stairs should vary by no more than 3/8 inch. At a minimum, be aware of this hazard, especially when guests who are not familiar with the stairs are present. Recommend that a qualified contractor repair per standard building practices.

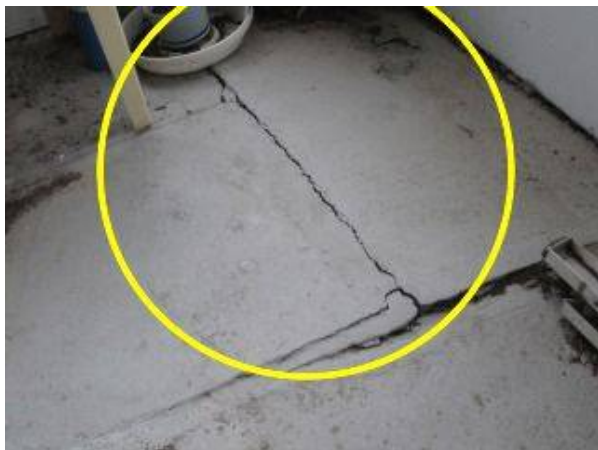
Photo 6-1

Cracks, holes, settlement, heaving and/or deterioration resulting in trip hazards were found in the patios. For safety reasons, recommend that a qualified contractor repair as necessary to eliminate trip hazards.

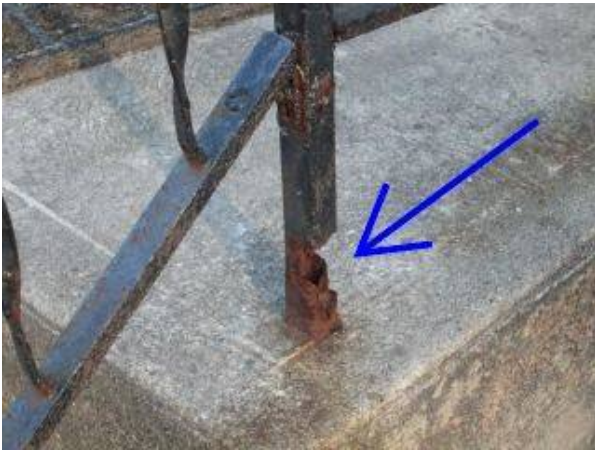
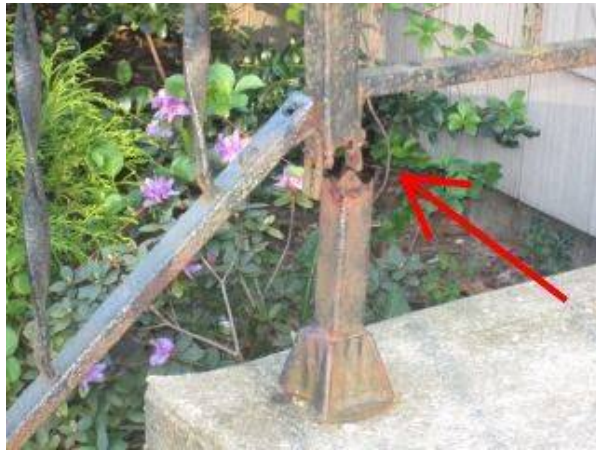
Guardrails at one or more flights of stairs were deteriorated. This is a safety hazard. Recommend that a qualified person repair as necessary.

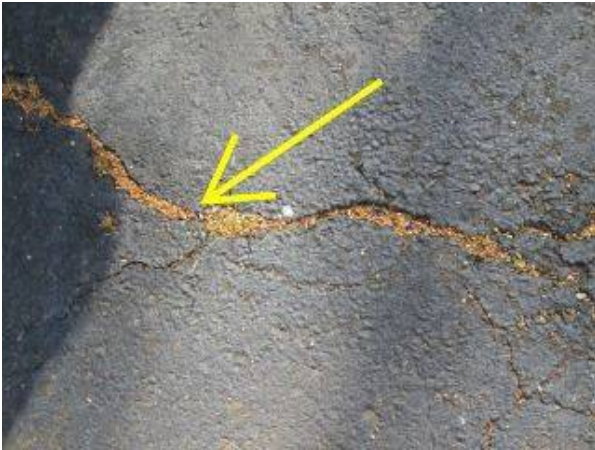
Photo 8-1

8) **i** Minor deterioration (e.g. cracks, holes, settlement, heaving) was found in the driveway, but no trip hazards were found. The client may wish to have repairs made for cosmetic reasons.

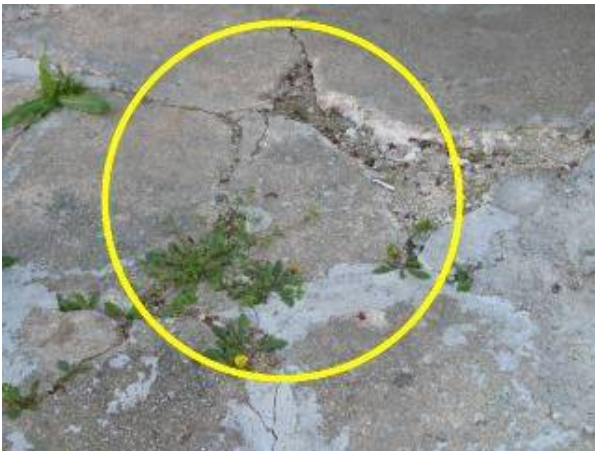
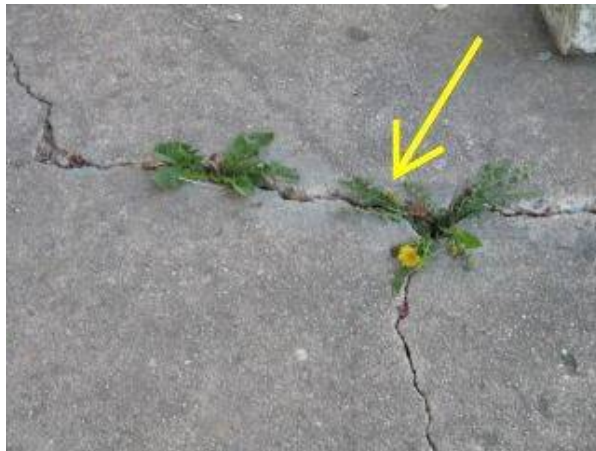
9) **i** Minor deterioration (e.g. cracks, holes, settlement, heaving) was found in sidewalks, but no trip hazards were found. The client may wish to have repairs made for cosmetic reasons.

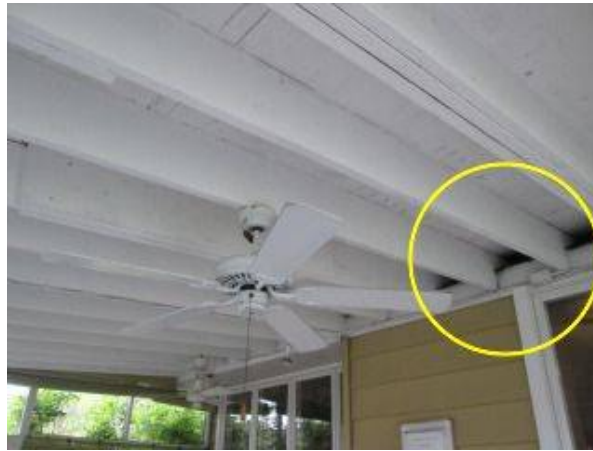
Photo 10-2

10) Sistered joists of the porches are not resting on the support .

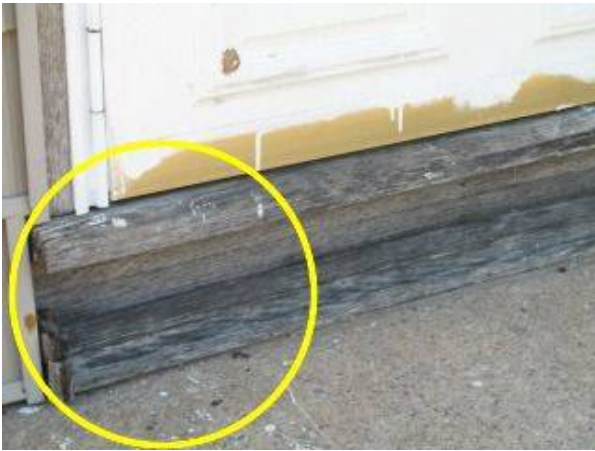
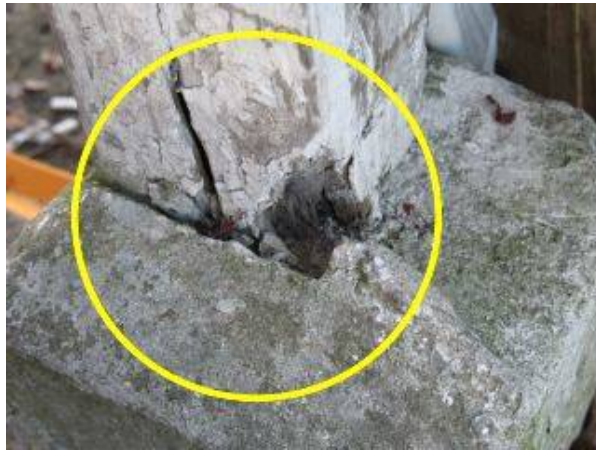
Untreated wood siding and/or trim was in contact with concrete or masonry at the exterior. Moisture collected between the two materials or wicking up into the wood is a conducive condition for wood-destroying organisms. Wood siding or trim should be installed with a minimum clearance of 1-2 inches between it and concrete or masonry below it at building exteriors. Monitor these areas for rot or infestation in the future and repair if needed. Recommend that a qualified person repair per standard building practices. For example, by trimming siding or trim as needed.

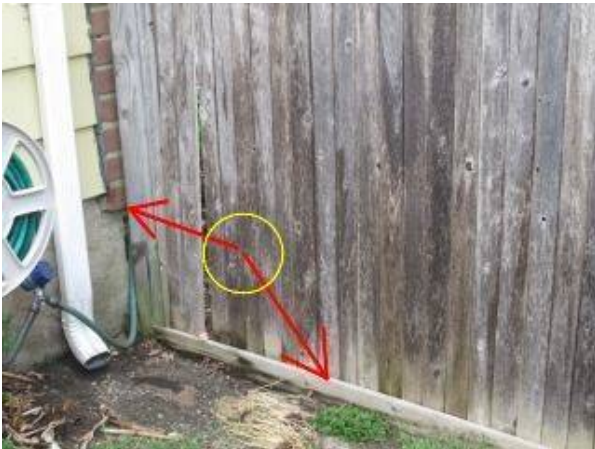
Photo 13-1

Fence(s) were attached to or in contact with the building exterior. Such attachments can serve as a pathway for wood-destroying insects and can retain moisture against the exterior after it rains. This is a conducive condition for wood-destroying organisms. Recommend that a qualified person repair as necessary so there is at least a 2-inch gap between fences and building exteriors.

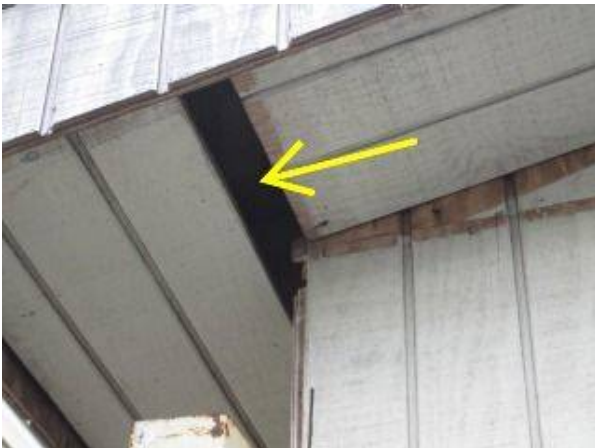
Photo 14-1

One or more holes or gaps were found in siding or trim. Vermin, insects or water may enter the structure. Recommend that a qualified person repair as necessary.

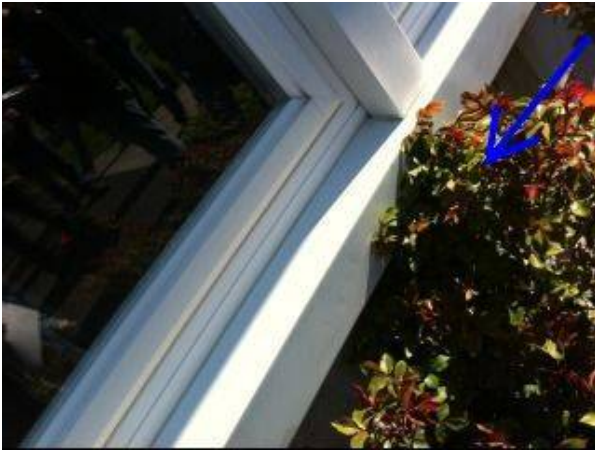
Photo 15-1

Vegetation such as trees, shrubs and/or vines was in contact with or close to the building exterior. Vegetation can serve as a pathway for wood-destroying insects and can retain moisture against the exterior after it rains. This is a conducive condition for wood-destroying organisms. Recommend pruning, moving or removing vegetation as necessary to maintain at least 6 inches of space between it and the building exterior. A 1-foot clearance is better.

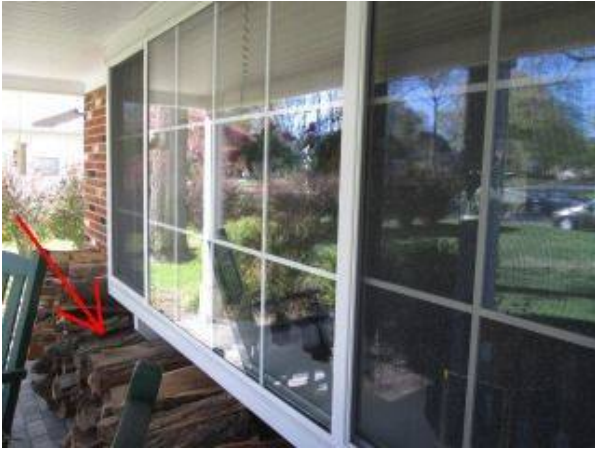
Photo 16-1

Firewood was stored so that it was in contact with or close to the building exterior. This is a conducive condition for wood-destroying organisms. Recommend storing firewood outdoors in an open area, and as far away from buildings as practical to keep insects away from buildings. For more information visit:

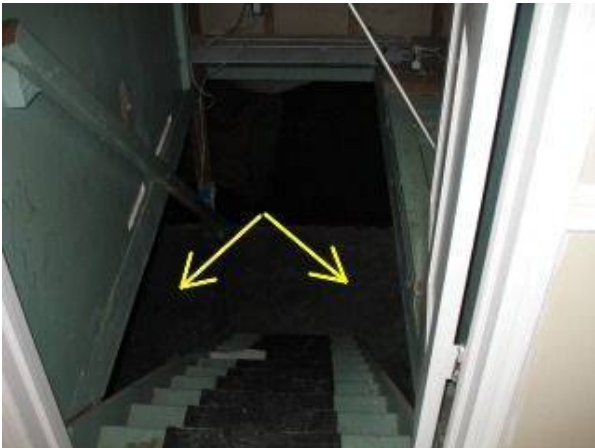
Photo 17-1

Handrails at one or more flights of stairs were missing. This is a potential fall hazard. Handrails should be installed at stairs with four or more risers or where stairs are greater than 30 inches high. Recommend that a qualified contractor install handrails where missing and per standard building practices.

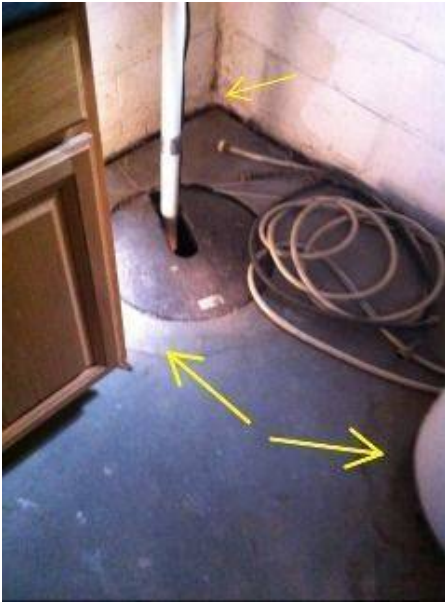
Photo 18-1

Evidence of prior water intrusion was found in one or more sections of the basement. For example, water stains or rust at support post bases, efflorescence on the foundation, etc. Accumulated water is a conducive condition for wood-destroying organisms and should not be present in the basement. Recommend reviewing any disclosure statements available and ask the property owner about past accumulation of water in the basement. The basement should be monitored in the future for accumulated water, especially after heavy and/or prolonged periods of rain. If water is found to accumulate, then recommend that a qualified contractor who specializes in drainage issues evaluate and repair as necessary. Typical repairs for preventing water from accumulating in basements include:

- Repairing, installing or improving rain run-off systems (gutters, downspouts and extensions or drain lines)
- Improving perimeter grading
- Repairing, installing or improving underground footing and/or curtain drains

Ideally, water should not enter basements, but if water must be controlled after it enters the basement, then typical repairs include installing a sump pump.

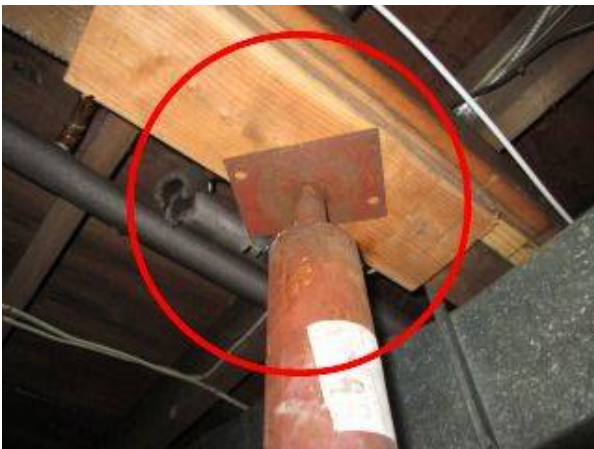
Photo 19-1

One or more adjustable steel columns were found. Some adjustable steel columns are rated for permanent use, but some are not. Based on the inspector's observations, columns in this building may not be rated for permanent use and may pose a safety risk for collapse. Recommend that a qualified contractor familiar with regulations surrounding use of such columns evaluate and repair if necessary, and per standard building practices.

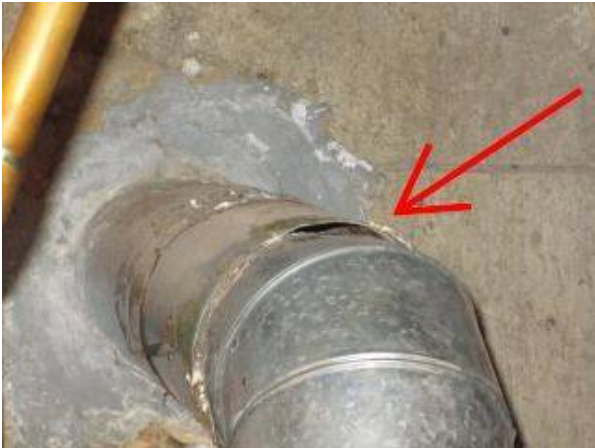
Photo 20-1

One or more exhaust ducts (e.g. bathroom fan, clothes dryer) in the have come apart, were loose or have fallen down. This can

result in increased moisture levels inside the structure and is a conducive condition for wood-destroying organisms. Recommend that a qualified person make permanent repairs as necessary.

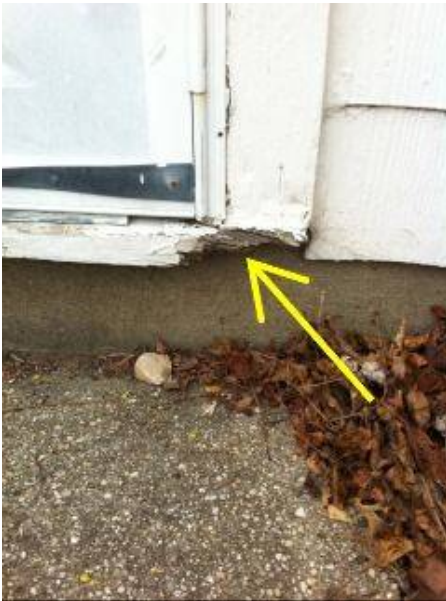
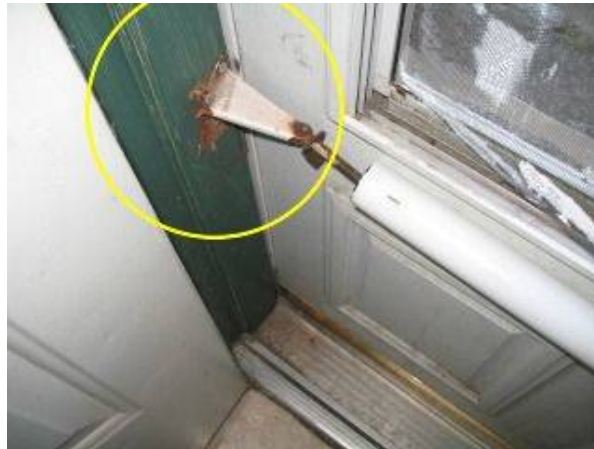
One or more exterior doors had minor damage and/or deterioration. Although serviceable, the client may wish to repair or replace such doors for appearances' sake.

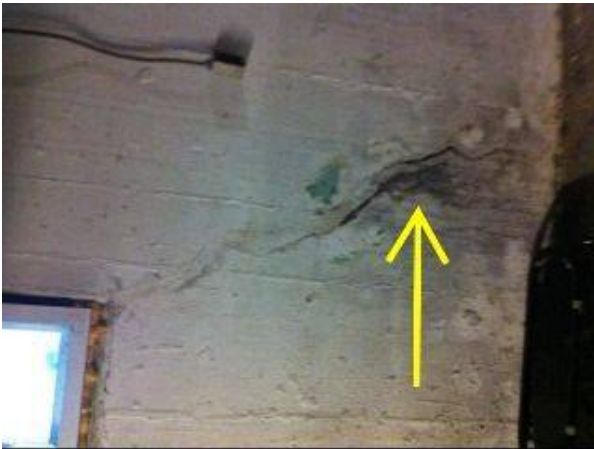
Photo 22-1

22) Settlement crack on the basement wall.
Recommend that a qualified contractor evaluate and repair per standard building practices;

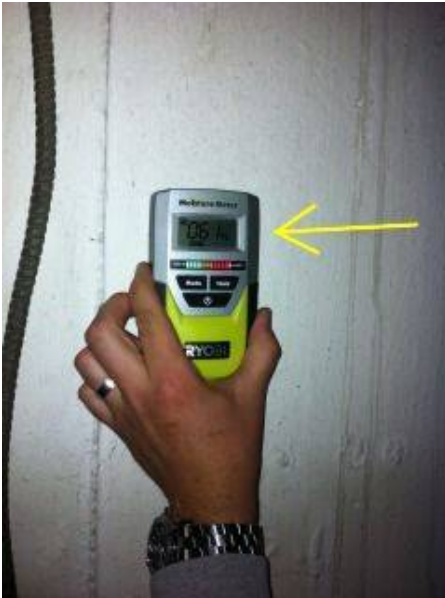
Photo 23-1

23) Moisture content of the basement wall was higher than normal .
This is the condition for microbial growths.
Evaluation by a qualified contractor is recommended.

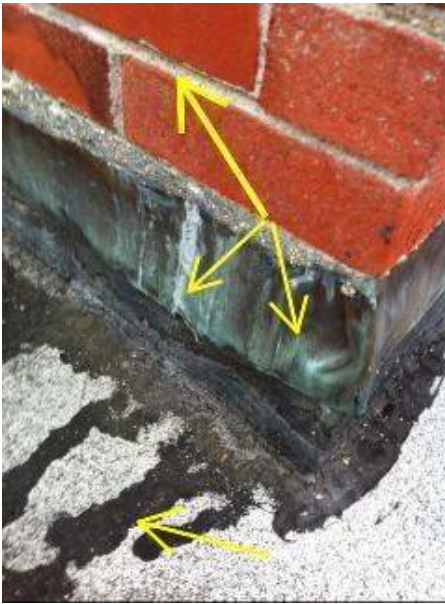
Photo 24-1

Flashings at the base of one or more chimneys were substandard. Leaks can occur as a result. This is a conducive condition for wood-destroying organisms. Recommend that a qualified contractor evaluate and repair as necessary.

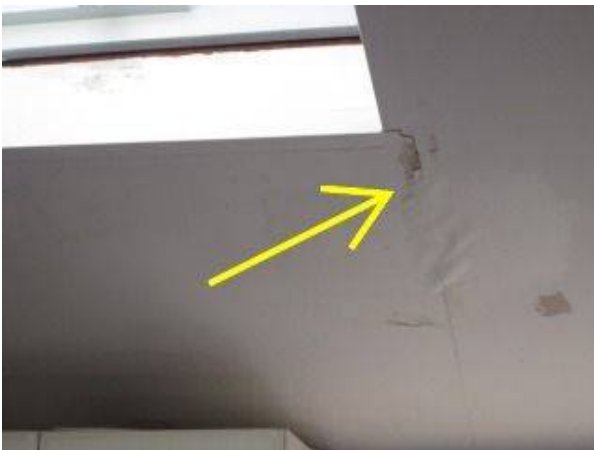
Photo 25-1

Water damage and/or evidence of past leaks was found at one or more skylights. Consult with the property owner to determine if leaks have occurred, or if repairs have been made. Recommend that a qualified contractor evaluate and repair as necessary.

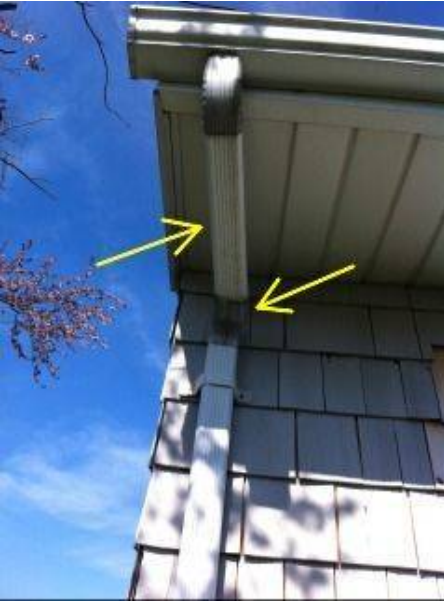
Photo 26-1

One or more gutters had a substandard slope so that significant amounts of water accumulate in them rather than draining through the downspouts. This can cause gutters to overflow, especially when debris such as leaves or needles has accumulated in them. Rainwater can come in contact with the building exterior or accumulate around the foundation as a result. This is a conducive condition for wood-destroying organisms. Recommend that a qualified person repair as necessary. For example, by correcting the slope in gutters or installing additional downspouts and extensions.

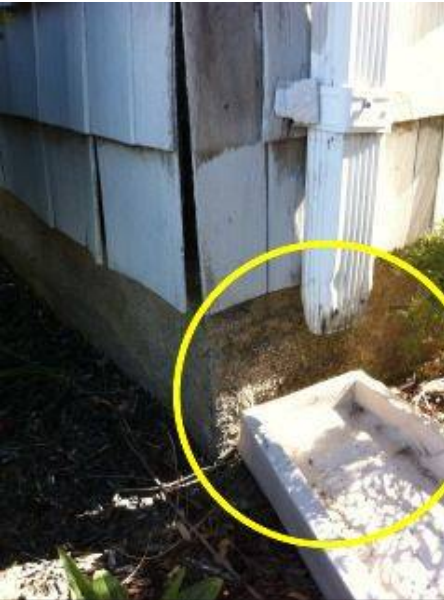
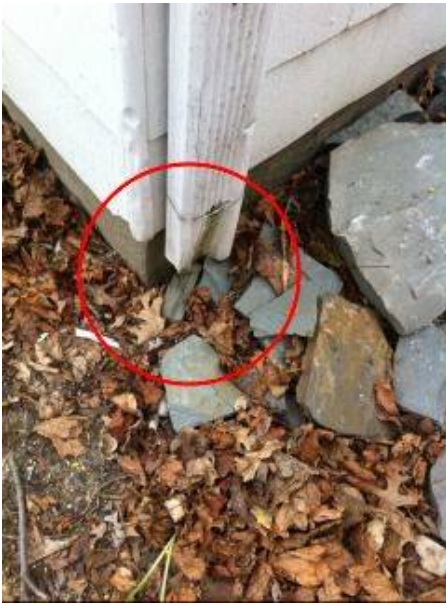
Extensions such as splash blocks or drain pipes for one or more downspouts were missing, substandard and/or damaged. Water can accumulate around the building foundation or inside crawl spaces or basements as a result. Recommend that a qualified person install, replace or repair extensions as necessary so rainwater drains away from the structure.

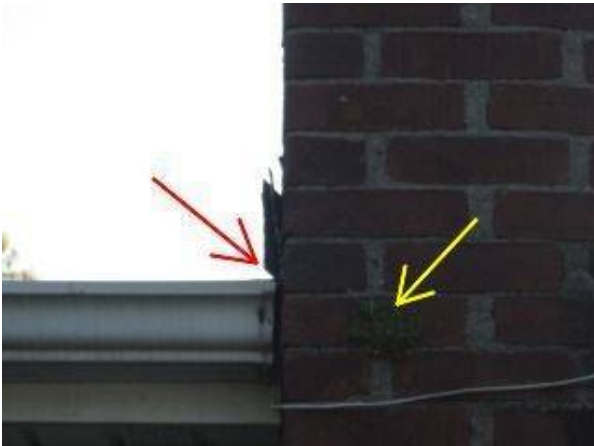
Photo 28-1

One or more roof flashings were substandard. Leaks can occur as a result. This is a conducive condition for wood-destroying organisms. Recommend that a qualified person repair as necessary.

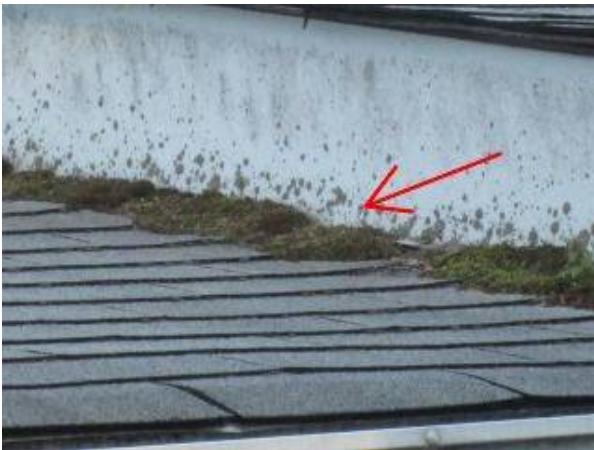
Photo 30-1

Moss was growing on the roof. As a result, shingles can lift or be damaged. Leaks can result and/or the roof surface can fail prematurely. Efforts should be made to kill the moss during its growing season (wet months). Typically, zinc or phosphate-based chemicals are used for this and must be applied periodically. For information on various moss treatment products and their pros and cons, visit:

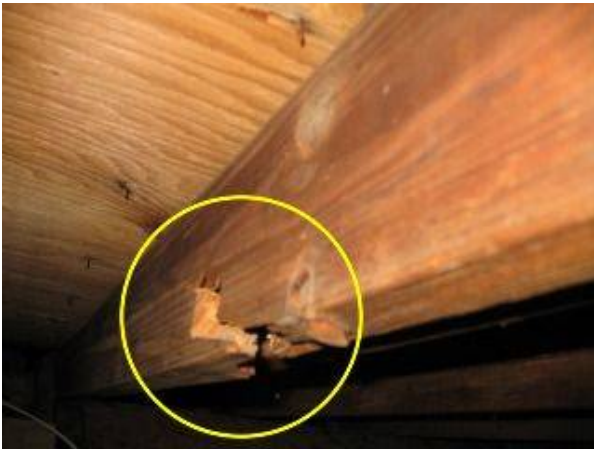
Photo 33-1

One or more rafters in the roof structure were damaged or split. This may significantly weaken the roof structure. Recommend that a qualified contractor repair as necessary.

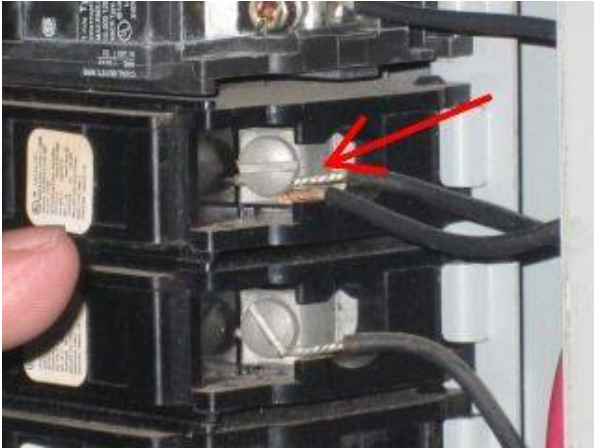
Photo 35-1

One or more circuit breakers in panel(s) # were "double tapped," where two or more wires were installed in the breaker's lug. Most breakers are designed for only one wire to be connected. This is a safety hazard since the lug bolt can tighten securely against one wire but leave other(s) loose. Arcing, sparks and fires can result. Recommend that a qualified electrician repair as necessary. For more information, visit:

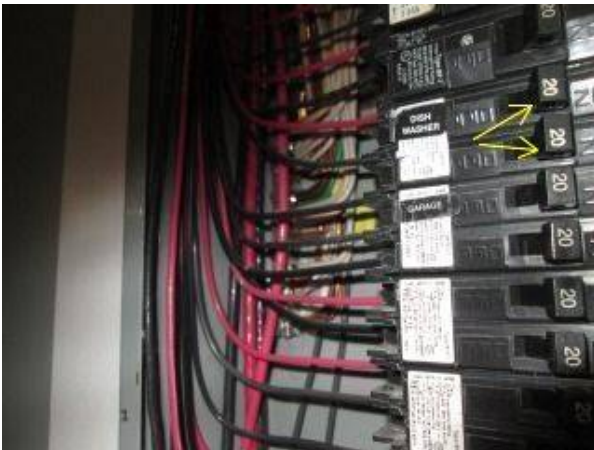
Photo 36-1

Handle ties were at one or more 2-pole or ganged 1-pole circuit breakers at panel(s) #. Approved, "identified" handle ties should be installed to prevent one side from being turned off while the other is turned on. Nails, screws or wires or other nonconforming material are not permitted for use as handle ties. This is a potential shock hazard, especially for someone working on the system. Recommend that a qualified electrician repair per standard building practices.

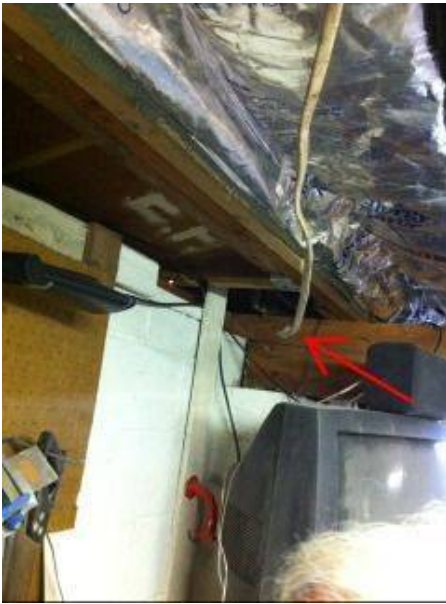
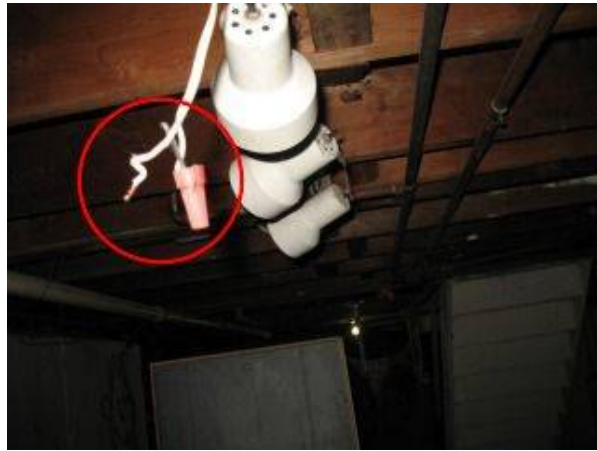
Bare wire ends, or wires with a substandard termination, were found at one or more locations. This is a potential shock hazard. Recommend that a qualified electrician repair as necessary. For example, by cutting wires to length and terminating with wire nuts in a permanently mounted, covered junction box.

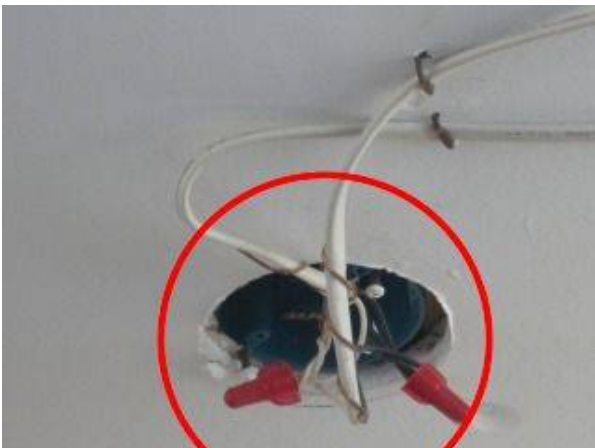
Photo 38-1

Wire splices were exposed and were not contained in a covered junction box. This is a potential shock or fire hazard. Recommend that a qualified electrician repair per standard building practices. For example, by installing permanently mounted junction boxes with cover plates where needed to contain wiring splices.

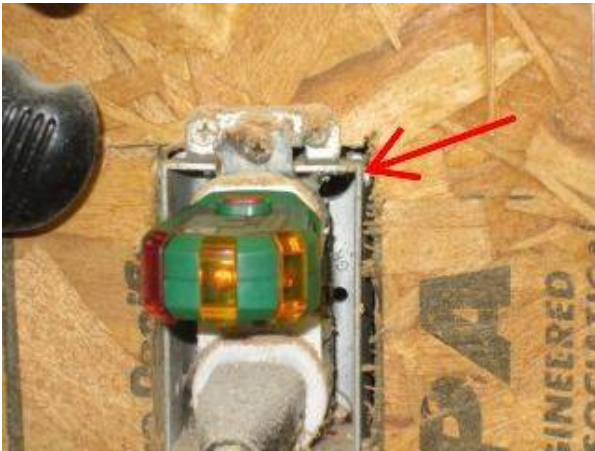
Photo 39-1

One or more receptacles (outlets) cover were broken or damaged. This is a potential shock or fire hazard. Recommend that a qualified electrician replace such receptacles as necessary.

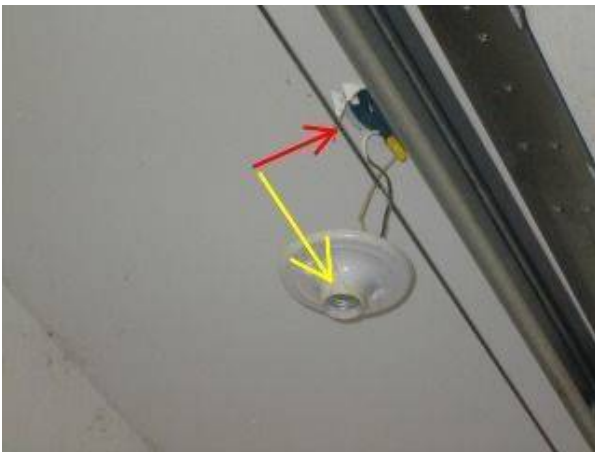
Photo 40-1

Lighting was missing at the detached garage. For safety and convenience, recommend that a qualified electrician install lighting as necessary, and per standard building practices.

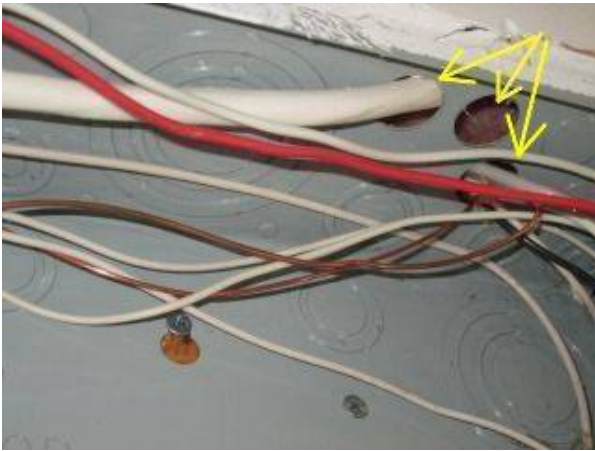
Photo 41-1

One or more bushings were missing from where wires enter holes in panel(s) #. This is a potential safety hazard because the wiring insulation can be cut or abraded on the metal edge of the hole(s). Recommend that a qualified electrician install bushings where missing.

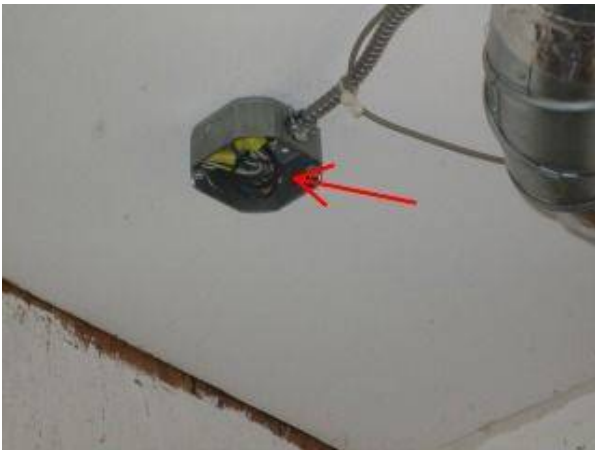
Photo 42-1

One or more cover plates for junction boxes were missing or broken. These plates are intended to contain fire and prevent electric shock from occurring due to exposed wires. Recommend that a qualified person install cover plates where necessary.

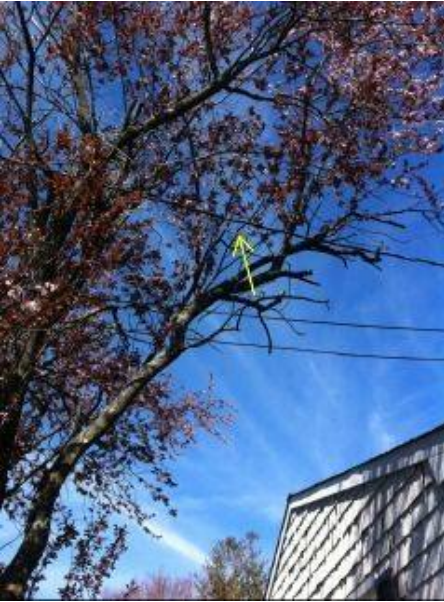
Photo 43-1

The service drop wires were in contact with trees or vegetation. This can result in damage to wiring insulation or broken wires during high winds. Recommend pruning trees or vegetation as necessary. The utility company may prune trees at no charge.

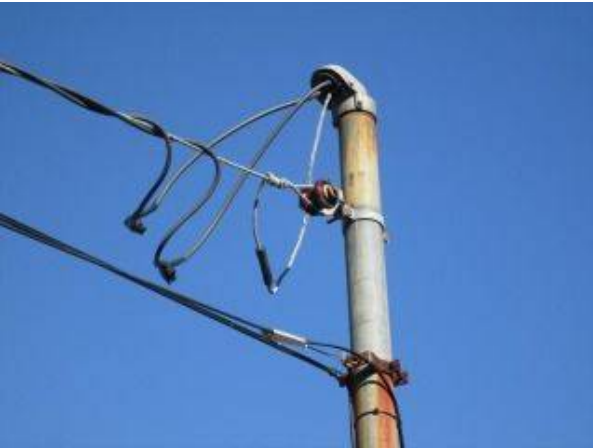
Photo 45-1

45) Service entrance conduit above meter was rusted .water may enter the meter base . recommend that a qualified electrician evaluate.

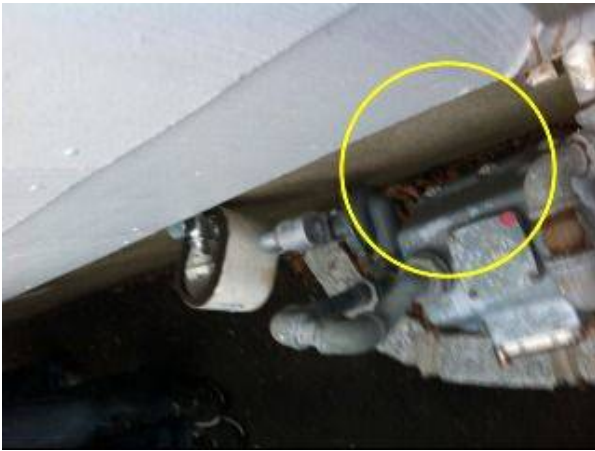
Photo 46-1

The gas meter was located next to the hose bib and too close to the wall and there was no protection in front of it on driveway this is a safety hazards . Recommend that repairs or modifications be made as necessary to maintain clearances per standard building practices, and by a qualified contractor or the gas utility company if necessary.

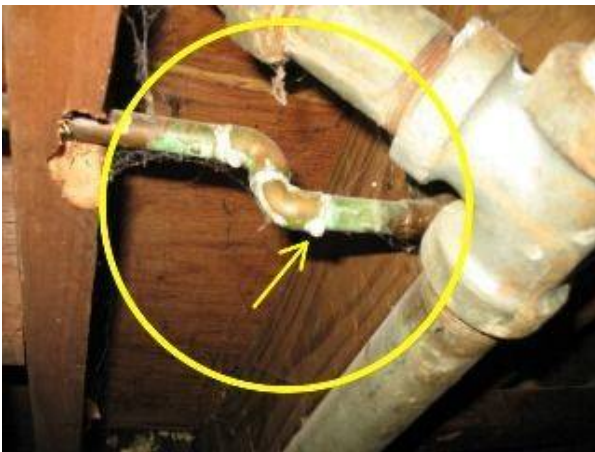
Photo 48-1

One or more leaks were found in water supply pipes or fittings. A qualified plumber should evaluate and repair as necessary.

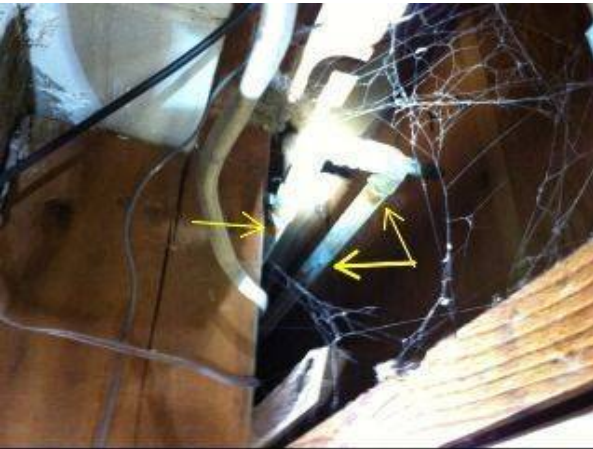
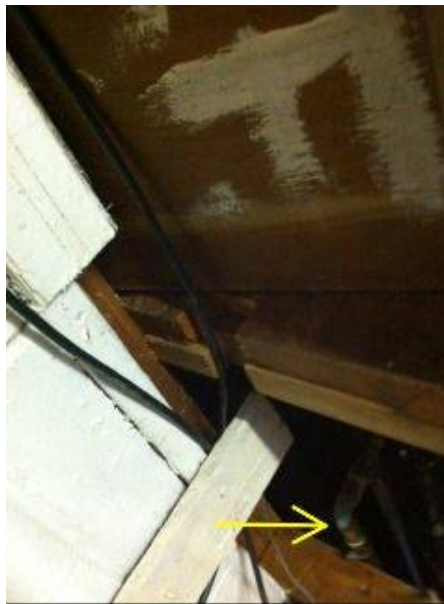
Significant corrosion was found in water supply pipes or fittings. Leaks can occur as a result. Recommend that a qualified plumber evaluate and replace components as necessary.

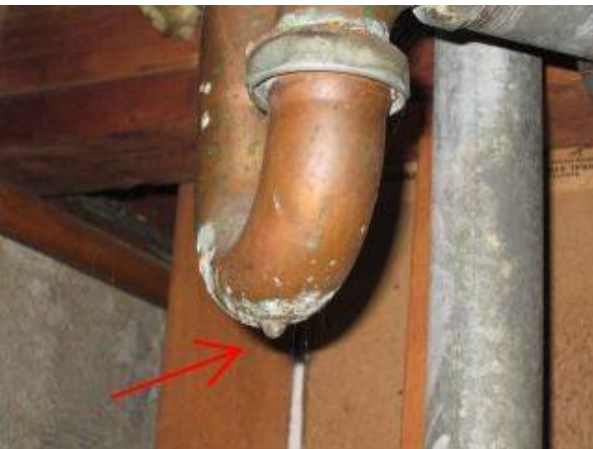
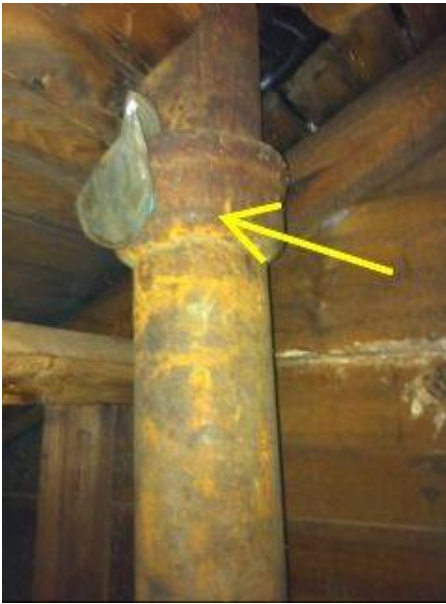
50) 🔧🔍 One or more leaks were found in drain and/or waste pipes or fittings. A qualified plumber should evaluate and repair as necessary.

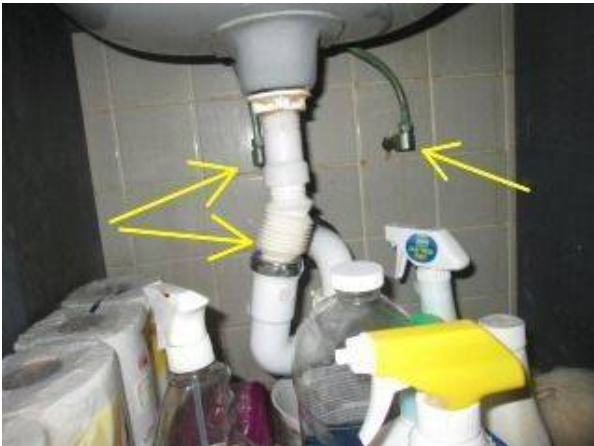
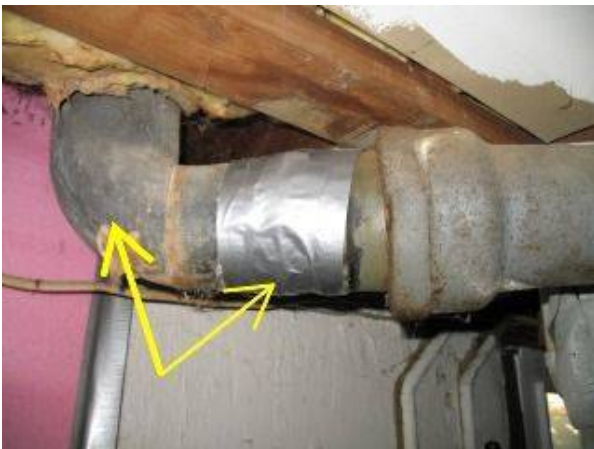
One or more drain pipes or fittings were substandard made of flexible plastic and lead. Recommend that a qualified plumber evaluate and repair as necessary and per standard building practices.

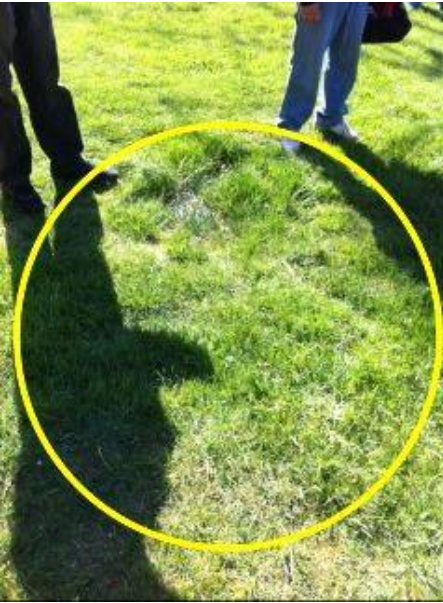
Photo 52-1

52) 🔑🔍 Based on visible components or information provided to the inspector, this property appeared to have a private sewage disposal (septic) system. These are specialty systems and are excluded from this inspection. Comments in this report related to this system are made as a courtesy only and are not meant to be a substitute for a full evaluation by a qualified specialist. Generally, septic tanks should be pumped and inspected every 3 years. Depending on the type of system and municipal regulations, inspection and maintenance may be required more frequently, often annually. Recommend the following:

- Consult with the property owner about this system's maintenance and repair history
- Review any documentation available for this system
- Review inspection and maintenance requirements for this system
- That a qualified specialist evaluate, perform maintenance and make repairs if necessary

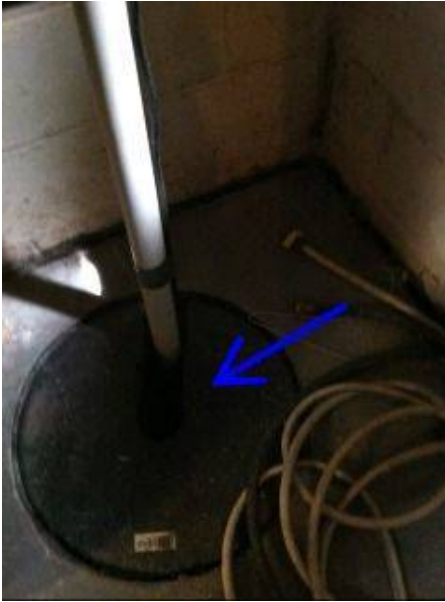
Photo 53-1

53) ⓘ A sump pump was installed in the basement. These are specialty systems and only a limited evaluation was performed as part of this inspection. The inspector does not determine the adequacy of sump pumps and their associated drainage systems. The presence of a sump pump may indicate that water routinely accumulates below or inside the structure. Recommend asking the property owner how often the sump pump operates and for how long at different times of the year. The client should be aware that the service life of most sump pumps is 5-7 years, and that the pump may need replacing soon depending on its age and how often it operates.

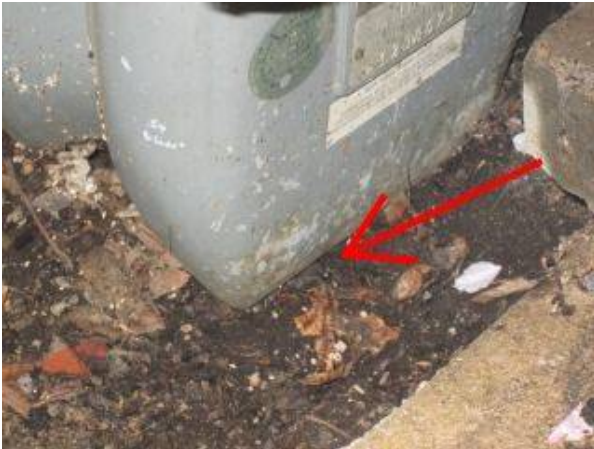
Photo 55-1

55) ⓘ The gas meter was in contact with or too close to the soil below and is likely to rust as a result. Gas meters should be located 10 inches or more above the soil below. Soil should be graded or removed as necessary.

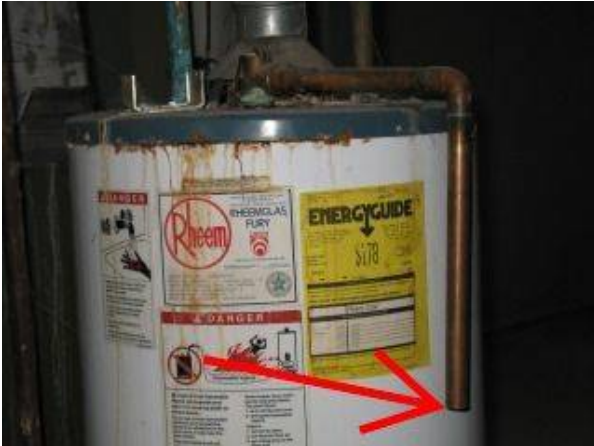
Photo 56-1

The temperature-pressure relief valve drain line was too short. This is a potential safety hazard due to the risk of scalding if someone is standing next to the water heater when the valve opens. Recommend that a qualified plumber repair per standard building practices. For example, by extending the drain line to within 6 inches of the floor, or routing it to drain outside. For more information, visit:

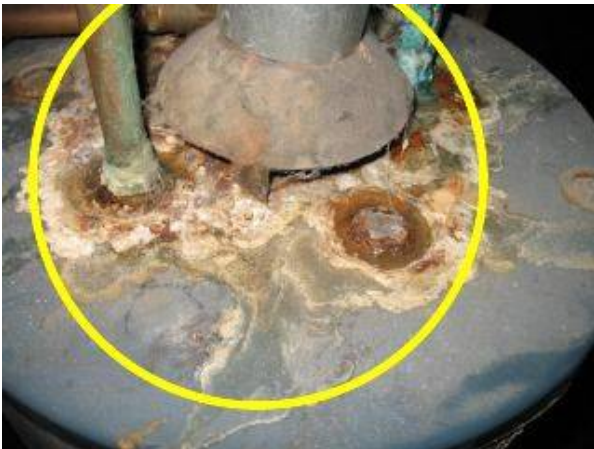
Photo 58-1

The water heater tank appeared to be leaking. This is an indication that the water heater has failed and is at the end of its service life. A qualified plumber should replace the water heater.

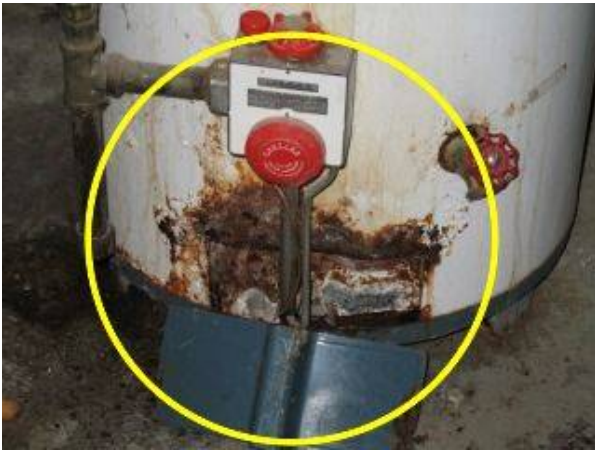
Photo 60-1

Significant corrosion or rust was found on the water heater tank casing. This is an indication that the water heater is near or at the end of its service life. At a minimum, monitor this water heater and budget for a replacement in the near future. Consider replacing the water heater now before any leaks occur. Significant flooding can occur if the water heater does fail.

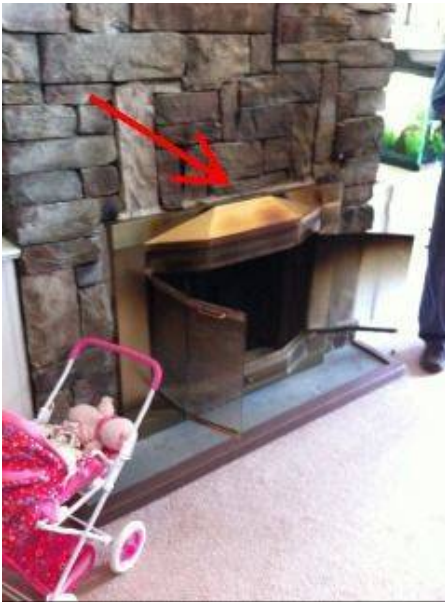
**Photo 65-1**

The fireplace hearth was undersized. Embers may ignite combustible surfaces nearby. This is a fire hazard. For fireplaces with a firebox less than 6 square feet in size, hearths should be at least 16 inches deep in front and extend at least 8 inches to the sides. For fireboxes more than 6 square feet in size, hearths should be at least 20 inches deep and extend 12 inches to each side. Recommend that a qualified person make repairs or modifications per standard building practices if necessary. For example, by installing a non-flammable hearth pad, or by extending the existing hearth with non-flammable materials.

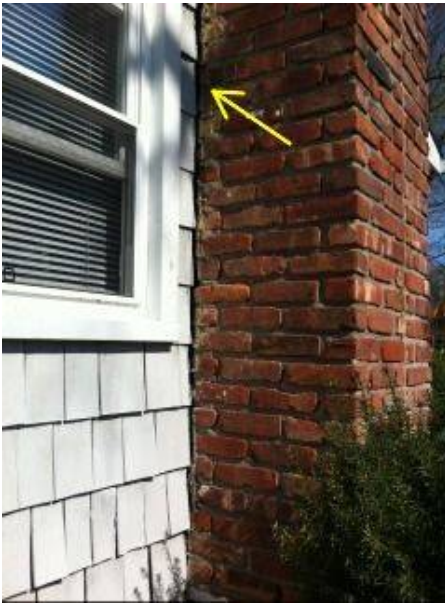
Photo 68-1

The brick chimney was deteriorated. For example, loose or missing mortar, and leaning away from the wall. Loose bricks can pose a safety hazard, and deteriorated masonry can allow water to infiltrate the chimney structure and cause further damage. Recommend that a qualified contractor repair as necessary.

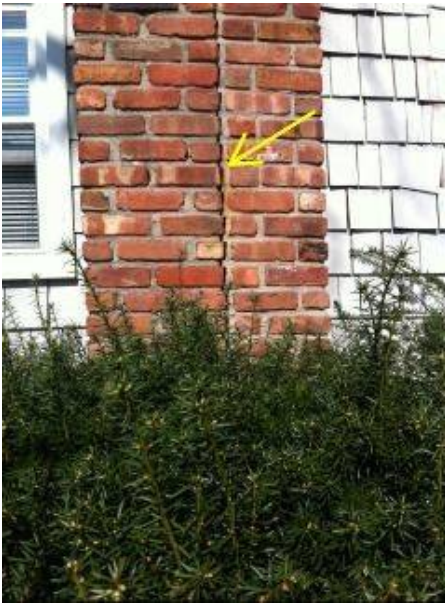
Photo 69-1

Mortar at the brick chimney was deteriorated (e.g. loose, missing, cracked). As a result, water is likely to infiltrate the chimney structure and cause further damage. Recommend that a qualified contractor repair as necessary. For example, by repointing the mortar.

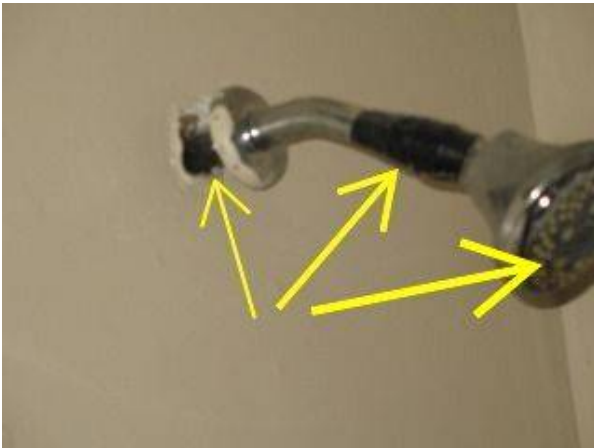
Photo 71-1

The shower head at location(s) #A was loose and dripping when the shower was turned off. Recommend that a qualified person repair and seal as necessary.

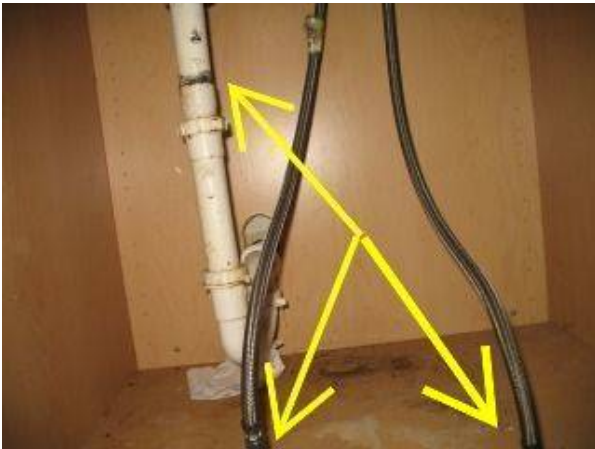
Photo 72-1

72) No shut-off valves under the sink in the bathroom .
substandard plumbing.recommend that a qualified person repair as necessary.

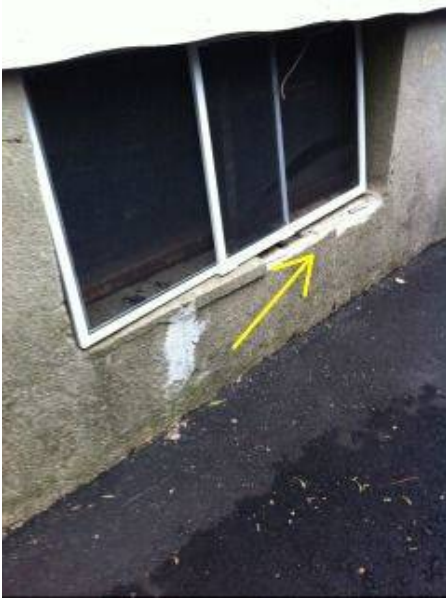
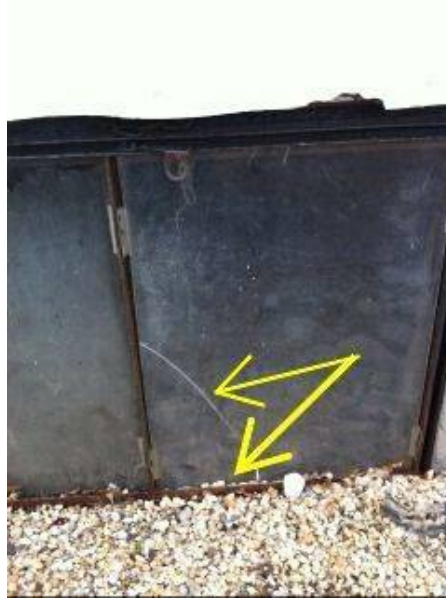
Glass in one or more was cracked, broken and/or missing. Recommend that a qualified contractor replace glass where necessary.

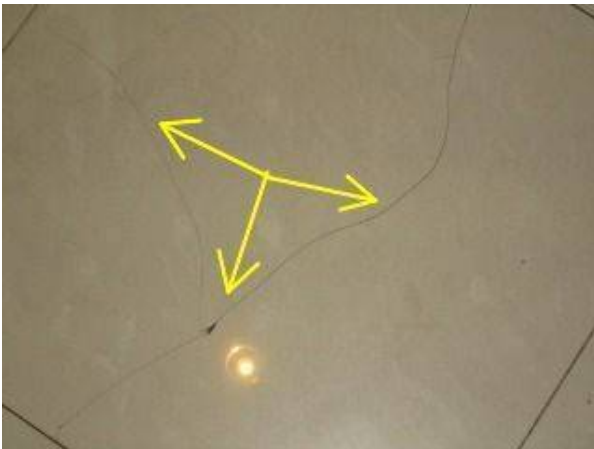
Photo 76-1

76) cracked tile on the kitchen floor

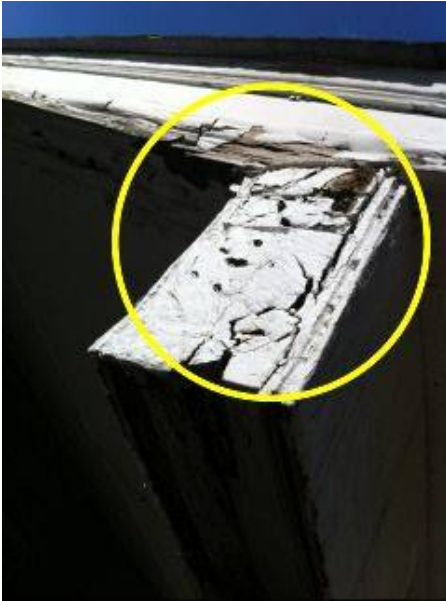
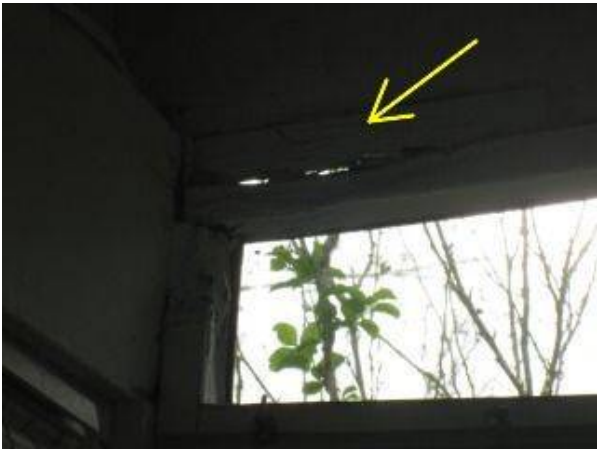
Because of apparent structural damage at location(s) #A and B, recommend that a qualified contractor evaluate and repair as necessary. All wood significantly damaged by wood-destroying insects or fungal rot should be replaced or removed.
