pink home inspection INC

Property Inspection Report

Inspection date: **Thursday, May 08, 2014**

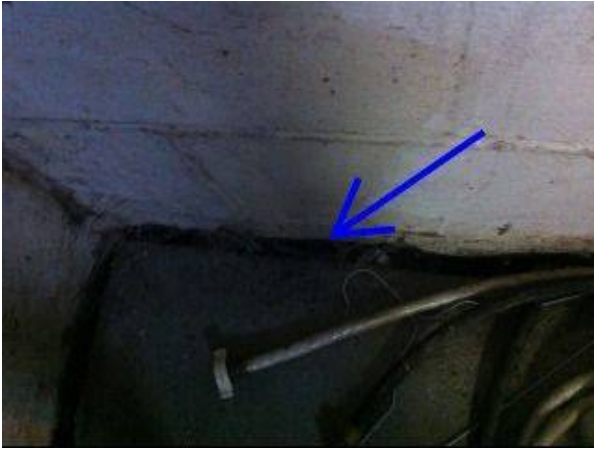
Photo 2-1

Microbial growths were found at one or more locations in the basement. It is beyond the scope of this inspection to identify what substance or organism this staining is. However such staining is normally caused by excessively moist conditions, which in turn can be caused by plumbing or building envelope leaks and/or substandard ventilation. These conducive conditions should be corrected before making any attempts to remove or correct the staining. Normally affected materials such as drywall are removed, enclosed affected spaces are allowed to dry thoroughly, a mildewcide may be applied, and only then is drywall reinstalled. For evaluation and possible mitigation, consult with a qualified industrial hygienist or mold/moisture mitigation specialist. For more information, visit:

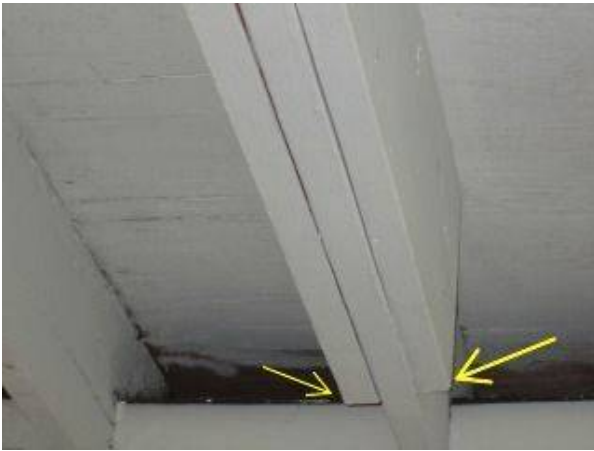
Photo 10-1

10) Sistered joists of the porches are not resting on the support .

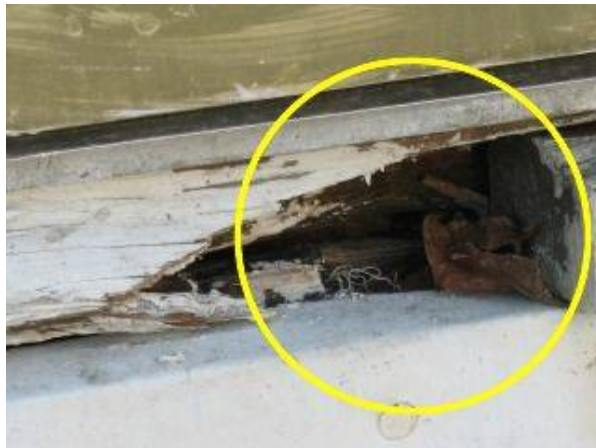
Photo 14-2

One or more holes or gaps were found in siding or trim. Vermin, insects or water may enter the structure. Recommend that a qualified person repair as necessary.

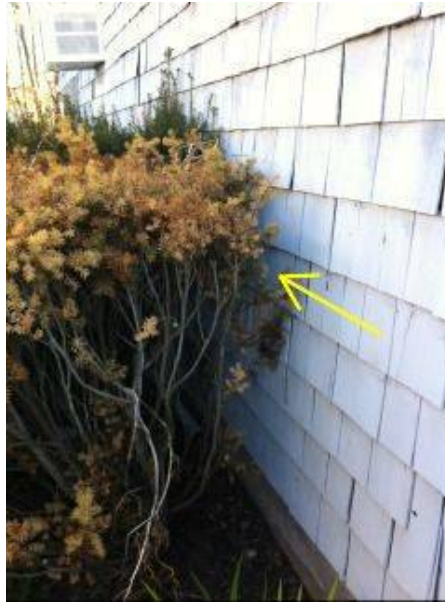
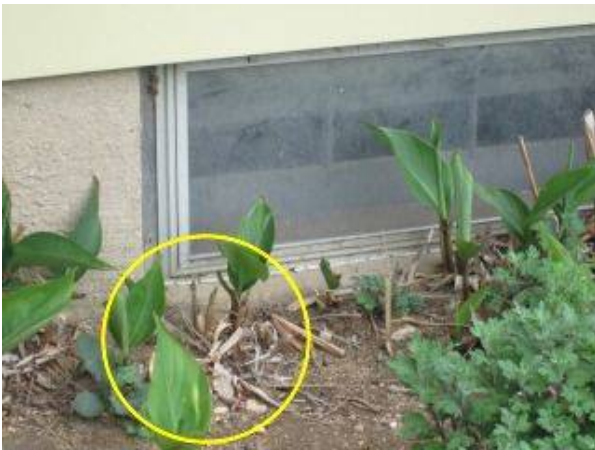
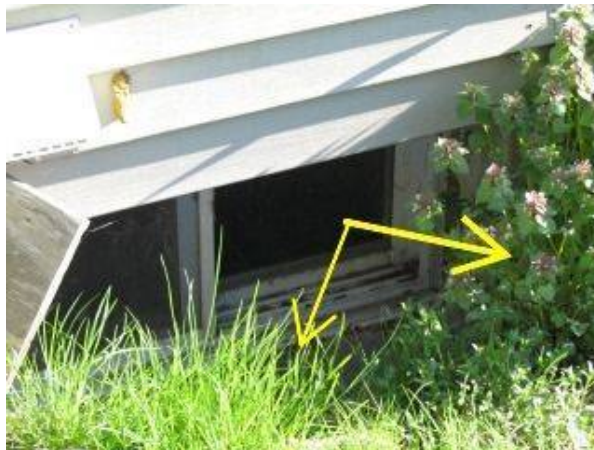
Vegetation such as trees, shrubs and/or vines was in contact with or close to the building exterior. Vegetation can serve as a pathway for wood-destroying insects and can retain moisture against the exterior after it rains. This is a conducive condition for wood-destroying organisms. Recommend pruning, moving or removing vegetation as necessary to maintain at least 6 inches of space between it and the building exterior. A 1-foot clearance is better.

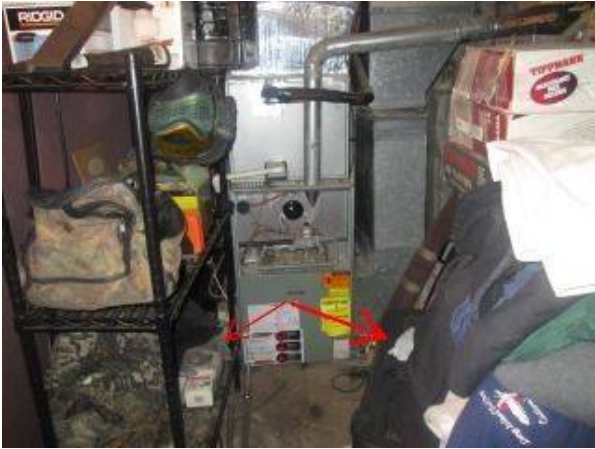
Photo 62-1

This is a potential fire hazard. Recommend any or all of the following as necessary:

- Research manufacturer's installation instructions to verify minimum allowable clearances
- Move combustible materials or have a qualified person make repairs as necessary

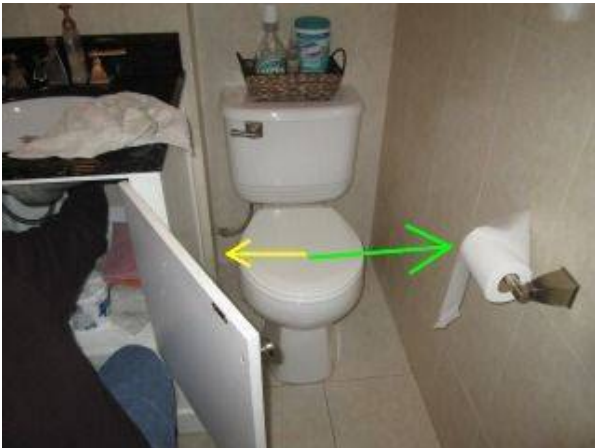
Photo 73-1

73) Substandard installation of toilet . too close to wall

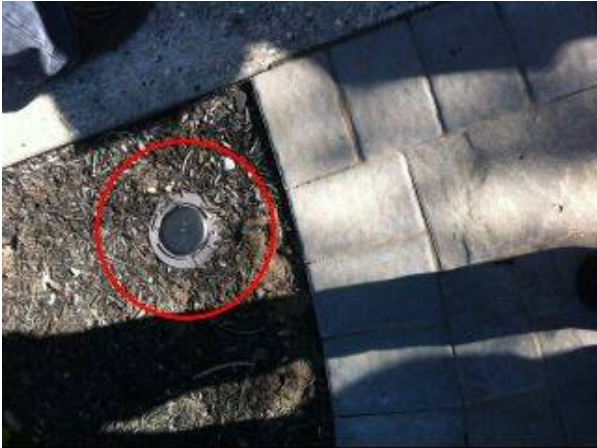
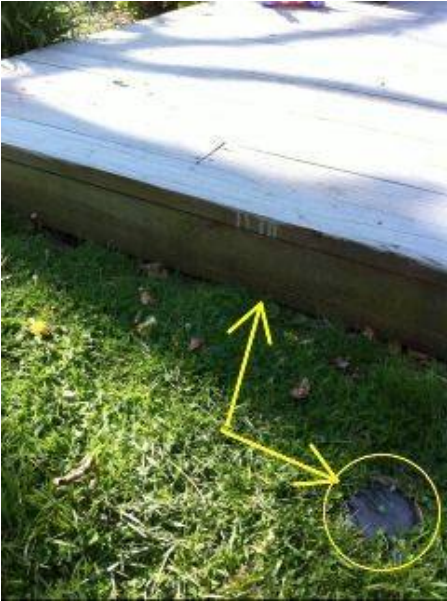
78) Evidence of prior treatment of termite was visible
